Bucket Lip Review

Review of Whisler 10 Lip System at South American Mine Site.

*Review is based on field inspections of
P&H 2800 and P&H 4100 bucket lips.*

Publication #01.2004
January 2004

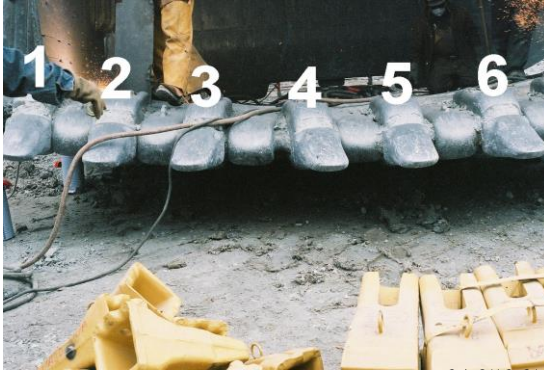
04.0110.01

Pictured here is an in-production P&H 4100 dipper bucket with used Esco style Whisler 10 Adapter assemblies. The unit location numbers, looking into the bucket, are left to right 1 to 9 and listed this way through out H&L's report. H&L Whisler 10 Adapter assemblies are located on the ground earmarked for field replacement of Esco Product. Before looking at the lip connections, one can see that the spacing between 3-4-5 are not equal. This indicates that there is most likely horizontal movement between Adapter #4 and in the lip connection number 4. At best condition, the lip horn has failed requiring maintenance replacement or at worst condition, a complete lip overhaul at the attachment connection.

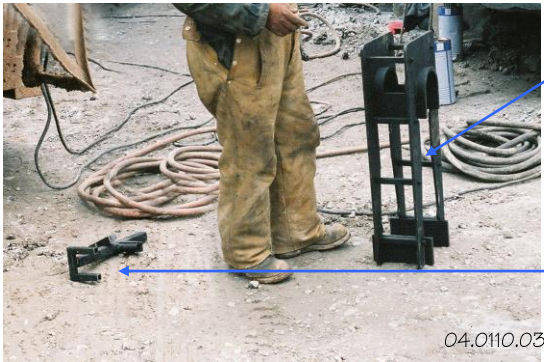
04.0110.03

Gauge X-2562-V maximum lip check and grinding profile. See publications M020.2003 for use. Also see M048.2004 for OEM dimensional review.

Gauge X-2562-N attachment hole location check. See publication M019.2003 for use.

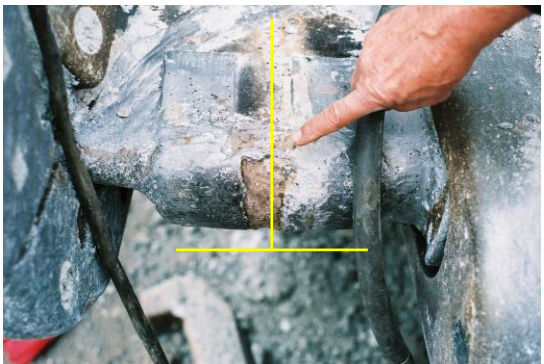
04.0110.04

Lip location #1:
Stabilizer has broken off at the leading corner radii surfaces. The front radii do not seem to be perpendicular to the mounting hole. Flat bearing surfaces on the front have not been maintained to OEM specification. Bearing surfaces of the rear pad were not checked but show excessive material upsetting. In this condition adapter movement is of major concern.

Recommendation: Rebuilding of the lip position should be done prior to any testing.

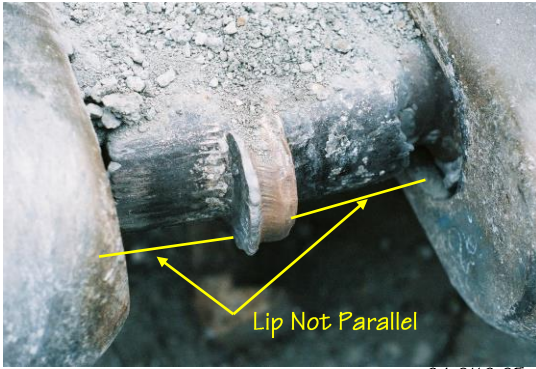
04.0110.05

Lip location #2:

Stabilizer shows contact on both sides of the vertical walls indicating adapter movement in operation. The front radii are not parallel and will not allow a proper adapter connection. Flat bearing surfaces on the front have not been maintained to OEM specification. Bearing surfaces of the rear pad were not checked but show excessive material upsetting. In this condition adapter movement is of major concern.

Recommendation: Rebuilding of the lip position should be done prior to any testing.

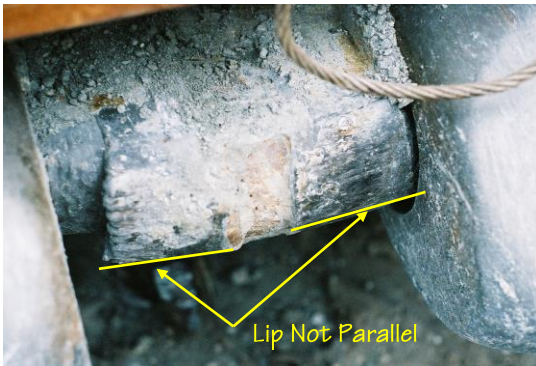
04.0110.06

Lip location #3:

Stabilizer has broken off at the leading corner radii surfaces. The front radii are not perpendicular, improper adapter connection will be the result. Flat bearing surfaces on the front have not been maintained to OEM specification. Dirt fines remain intact at the stabilizer and radii-bearing surface indicating that there has been no contact at any time. Bearing surfaces of the rear pad were not checked but show excessive material upsetting. In this condition adapter movement is of major concern.

Recommendation: Rebuilding of the lip position should be done prior to any testing.

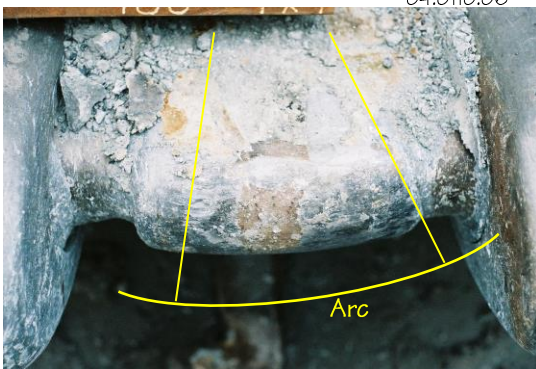
04.0110.07

Lip location #4:

The front radii surface is completely rounded, adapter assembly pivoting from the key/clamp attachment has created lip arcing. Indication of an assembly problem can be seen in picture 04.0110.01 prior to removal of the Wh-10 Assembly. Dirt fines remain intact at the radii-bearing surface indicating very little contact between adapter and the lip.

Recommendation: Rebuilding of the lip position should be done prior to any testing.

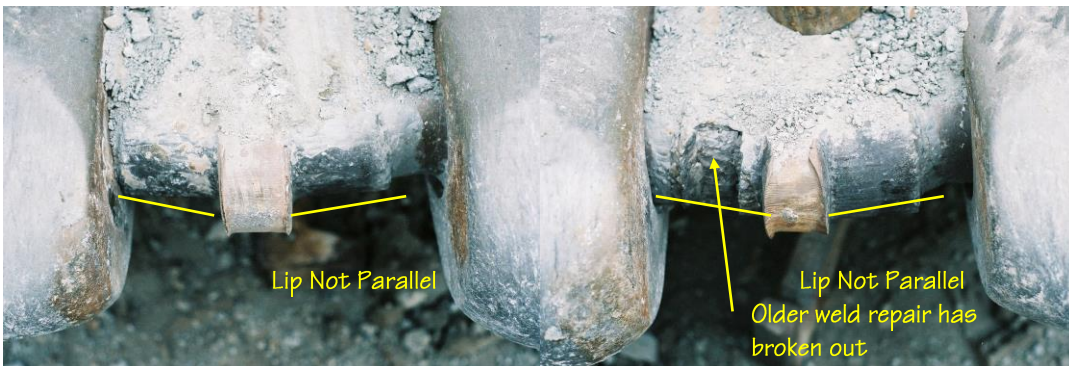
Lip location #5 and #6: Both stabilizers show contact on either sides. Position #6 has upset lip material on the vertical stabilizer wall indicating massive adapter movement in operation. The front radii are not parallel to each other. Flat bearing surfaces on the front have not been maintained to OEM specification. The rear bearing pads show signs of movement as all other adapter to lip locations.

Recommendation: Rebuilding of the lip position should be done prior to any testing.

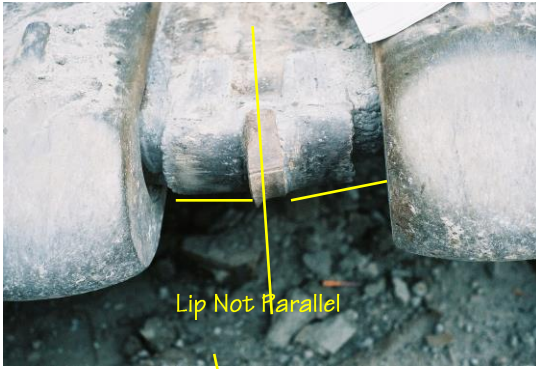
04.0110.10

Lip location #7:

Stabilizer shows contact on both sides of the vertical walls indicating adapter movement in operation. The front radii are not parallel and will not allow a proper adapter connection. Flat bearing surfaces on the front have not been maintained to OEM specification. Flat bearing surfaces of the rear pad were not checked but show excessive material upsetting.

Recommendation: Rebuilding of the lip position should be done prior to any testing.

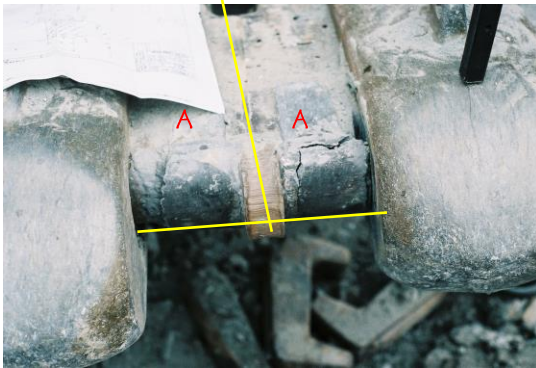
04.0110.11

Lip location #8:

Prior stabilizer repair worked fairly well. Horizontal side movement exists at location #8, but less movement than all others. The previous weld repair seen here has failed and a lip peeling crack starting at the top radius, extending approximately 12” towards the mounting hole on the bottom surface was noted, cracking was created by an improper adapter to lip radii contact. Vertical loads should be transferred into the flat bearing surfaces. The lip bearing surfaces “A” are undersized and did not allow the vertical stabilization of the adapter.

Recommendation: Rebuilding of the lip position should be done prior to any testing.

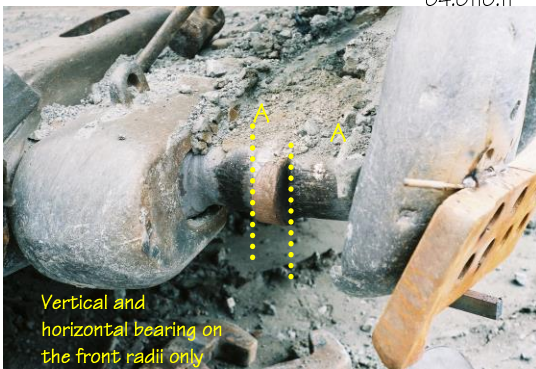
04.0110.12

Lip location #9:

Stabilizer show some contact on both sides of the vertical walls indicating a little adapter movement in operation. The front radii from a prior weld rebuild, shows a little contact near each side of the stabilizer. Flat bearing surfaces on the front are not maintained to OEM specification allowing vertical movement in operation. Flat bearing surfaces was covered with dirt fines, this indicates minimum to no vertical load distribution being placed onto the lip flats noted as “A”.

Recommendation: Rebuilding of the lip position should be done prior to any testing.

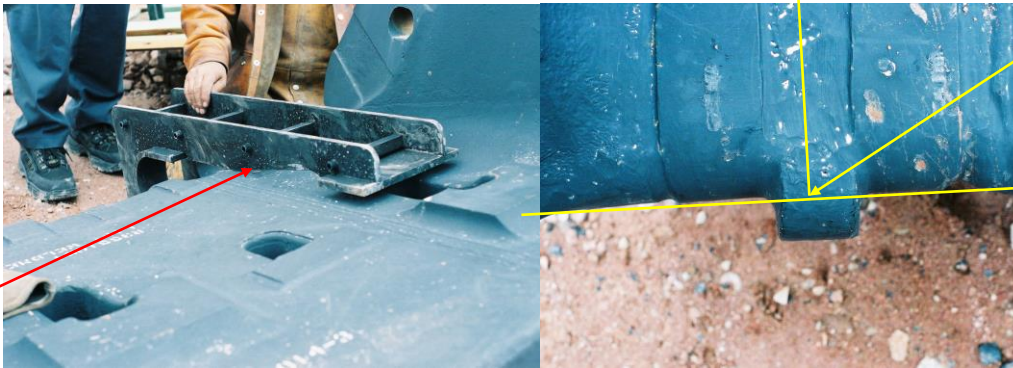
Note the perpendicular alignment between the stabilizer/mounting hole and the radii surface on each side of the stabilizer. THIS IS A GOOD ALIGNMENT.

Further evidence that the OEM has not offered additional maintenance rebuild information is mine maintenance personnel had purchased a new spare P&H 2800-bucket lip for installation. When we checked this new lip to the factory requirement (X-2562-N Gauging) we found that the flat bearing surfaces were all over the maximum allowable tolerance that all manufacturers specify, including P&H (reference P&H gauge drawings G-55639 and G-55766 from 1975).

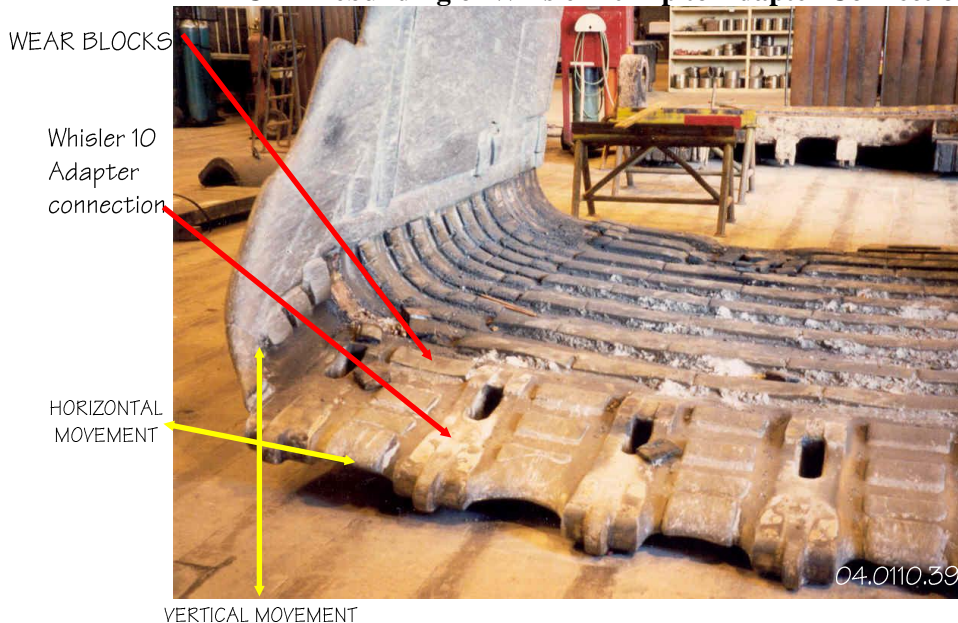
04.0110.39

Shown here is a typical rebuilding of a Whisler 10 adapter system from a mine site in Arizona, USA.

Mine maintenance personnel elected to not use lip shrouding provided by the OEM. Instead, they weld into position wear blocks that are replaced during scheduled shop maintenance. Increased weld time is involved, but overall downtime has been reduced by not requiring precision fit of the shroud positions during maintenance.

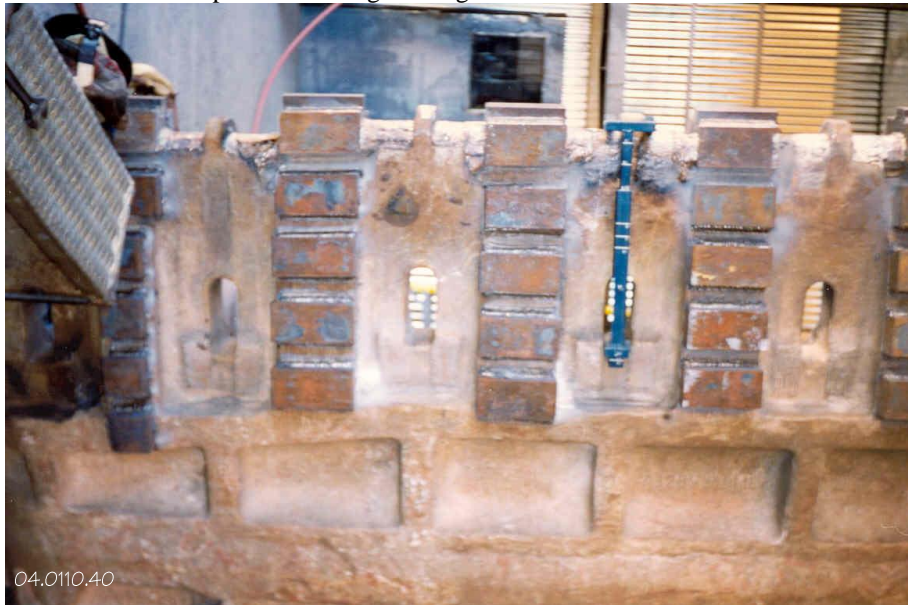
Shown here is the same Arizona Whisler 10-bucket lip with rebuilding being completed.

Note that all weld passes have been ground to fit lip gauging, passing the OEM standards that have been established

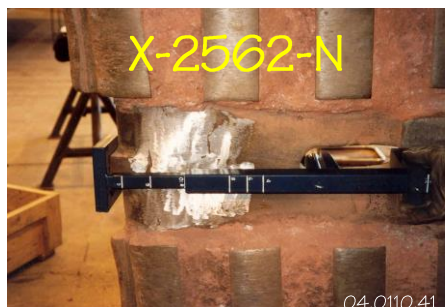
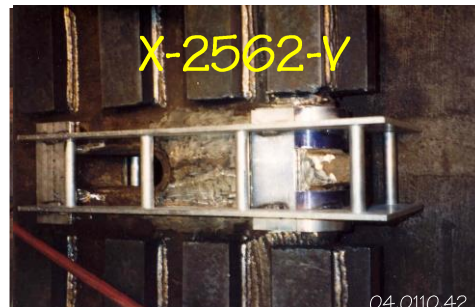
Pictures show a typical gauge inspection of a rebuild Whisler 10-bucket lip. Work being performed by an Arizona mine maintenance group. This Whisler 10 system does not use wear shrouds between the adapter assemblies, they use weld-on replaceable blocks.
