Bucket Lip Review

Review of Whisler 10 Lip System at South American Mine Site.

*Review is based on field inspections of
P&H 2800 and P&H 4100 bucket lips.*

Publication #01.2004
January 2004

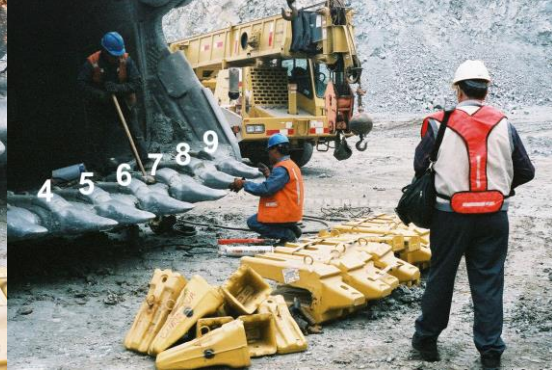
04.0110.02

Pictured here is an in-production P&H 4100 dipper bucket with used Esco style Whisler 10 Adapter assemblies. The unit location numbers, looking into the bucket, are left to right 1 to 9 and listed this way through out H&L's report. H&L Whisler 10 Adapter assemblies are located on the ground earmarked for field replacement of Esco Product. Before looking at the lip connections, one can see that the spacing between 3-4-5 are not equal. This indicates that there is most likely horizontal movement between Adapter #4 and in the lip connection number 4. At best condition, the lip horn has failed requiring maintenance replacement or at worst condition, a complete lip overhaul at the attachment connection.

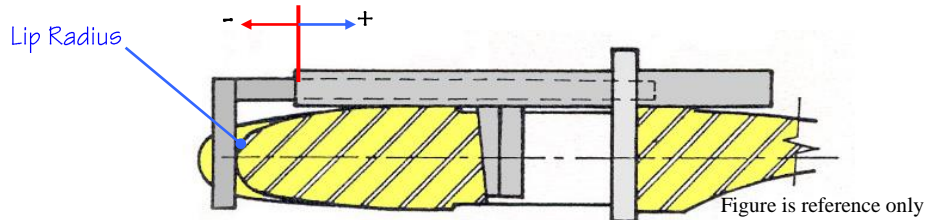
Note that if the mounting hole alignment exceeds $.380''/10\text{mm}$ in either direction repair for hole location should be done. If a measurement of over $.38''$ to the negative (-) side, welding of the lip radii will be needed to bring the measurement back into factory tolerance. If a measurement of over $.38''$ to the positive (+) side, grinding will be required to match the factory tolerance.

1. Check lip fit with a precision made repair/check gauge. H&L offers two gauge that check two different fits of a Whisler design. Gauge X-2562-N checks for proper hole mounting and X-2562-V for weld and grind fits.
2. Use a soapstone and gauge X-2562-N, mark the gauge and measure the difference between the soapstone mark and gauge line created with part A and part B as noted on publication M018.2003 and M019.2003, dimension should not exceed .240"/6mm in either direction. A smaller (+) or larger (-) wedge Key could be required to assemble the adapter. The rear of the hole can also be checked, a less critical dimension, by measuring the difference of line location of part B and part C.

3. With the mounting hole correctly established as note above, the lip bearing pads can be inspected. Front radii and bearing surfaces as well as the rear bearing pads of your lip needs to be checked for excessive wear, this is done by installing gauge #X-2562-V to your lip, see publication M047.2004. Grinding of up-set lip material due to adapter movement prior to placing gauge on the lip areas to be maybe required.
